#### INSTALLATION & ALIGNMENT OF WIRE ROPE GRIPS (DIN GRIPS)

#### UPPER ANCHORAGES:

#### UNUSUAL MECHANICAL DAMAGE

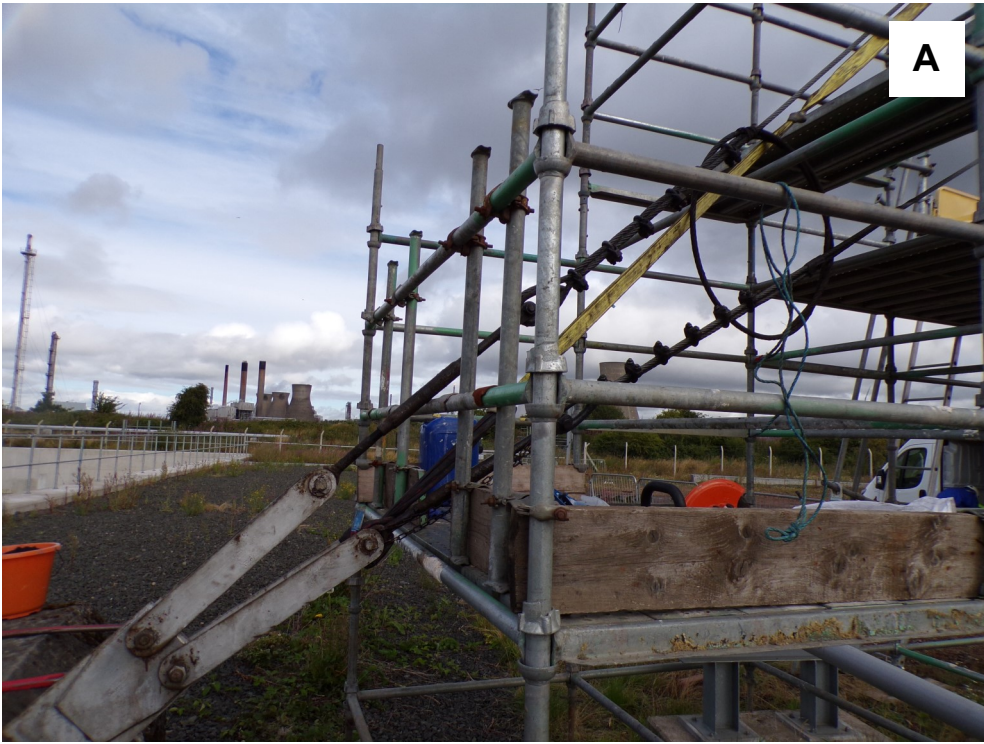
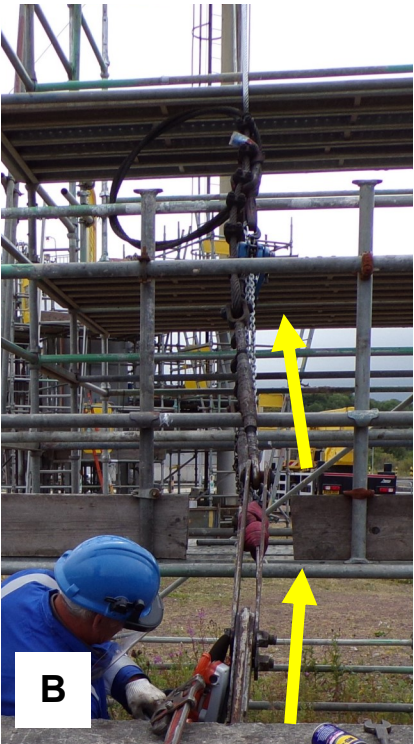
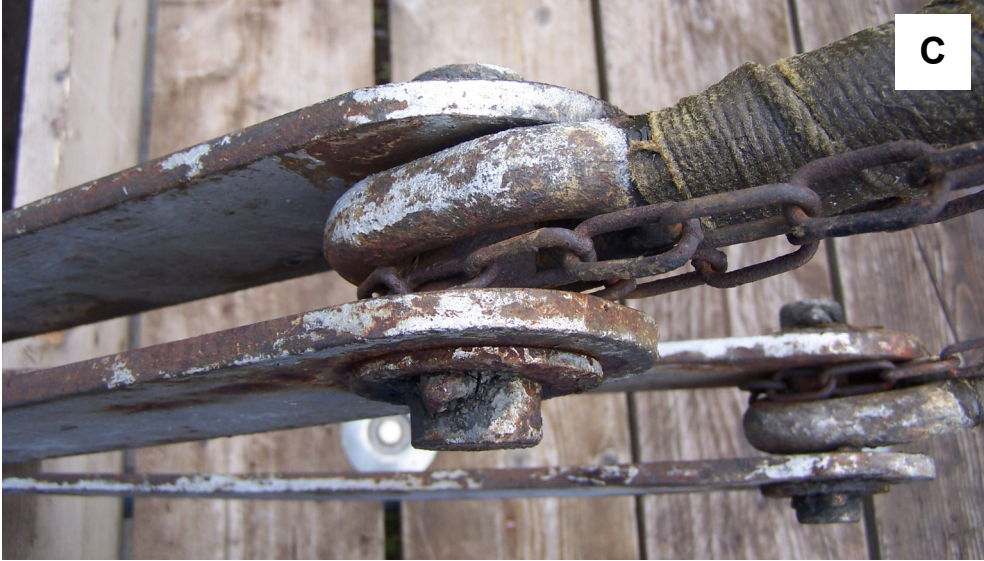
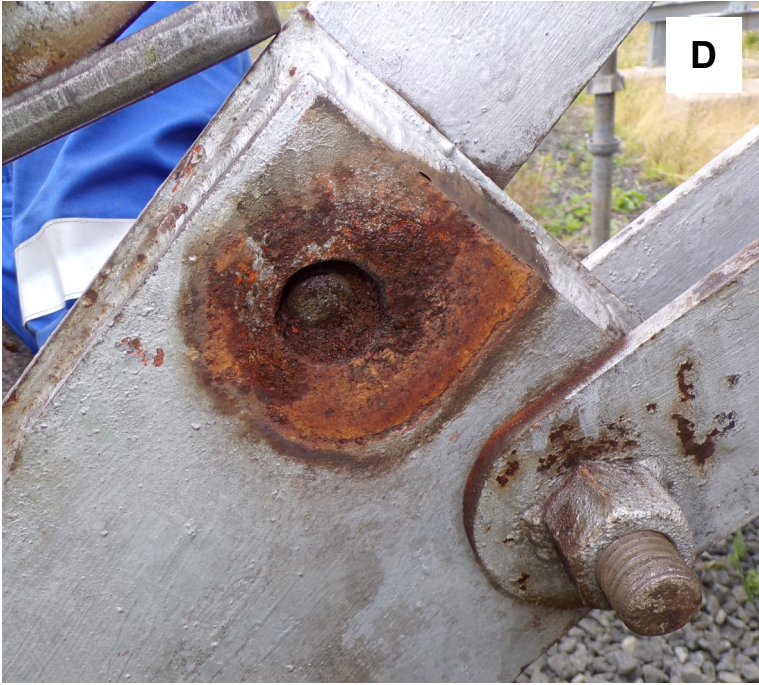
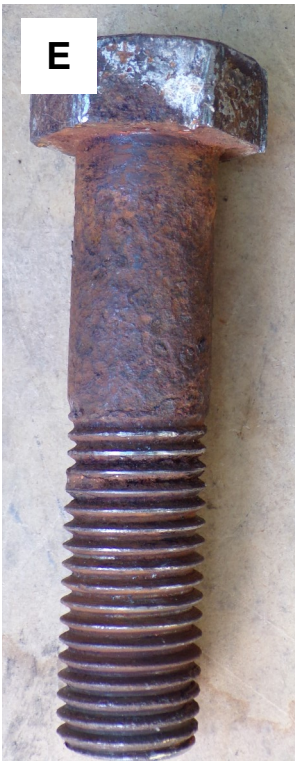
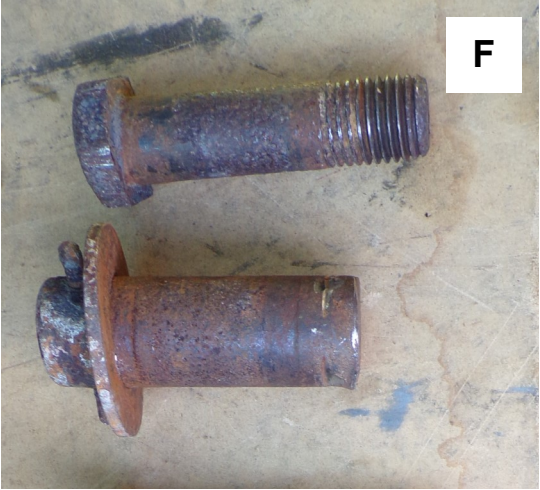
A — General arrangement at the Ground Anchors  
B — At this anchorage the Anchor Plate in the 'Dead-man' can be seen to be out of line with the guy rope meaning that the force on the corresponding Link Plates is also offset.

C, D E & F — All of the anchor bolts were severely affected by corrosion; by incorporating the arrangement shown in Photograph G it was possible to eliminate all of these at minimum cost.

We were able to significantly rectify this situation by linking the Guy Rope to the Ground Anchor using a Wire Rope Strop and a large Bow Shackle (Photograph G).

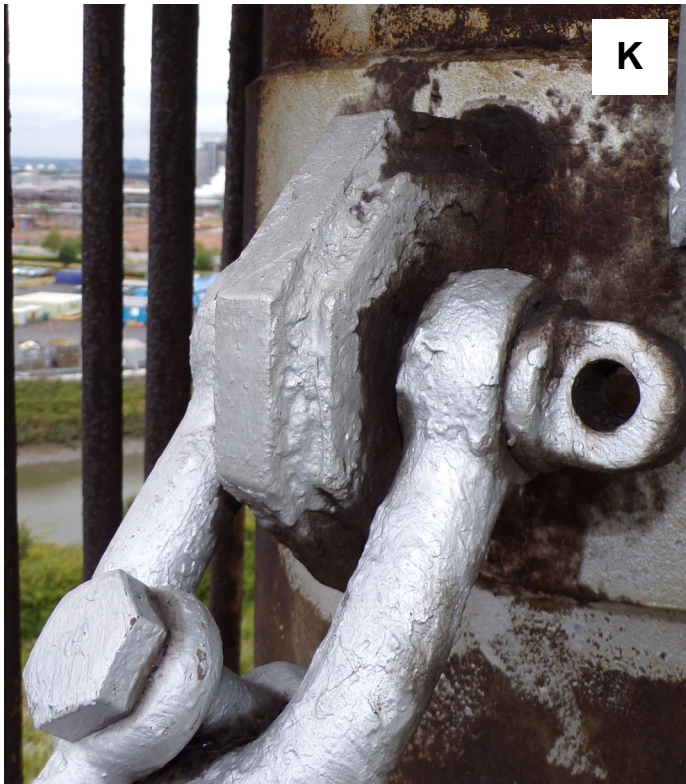
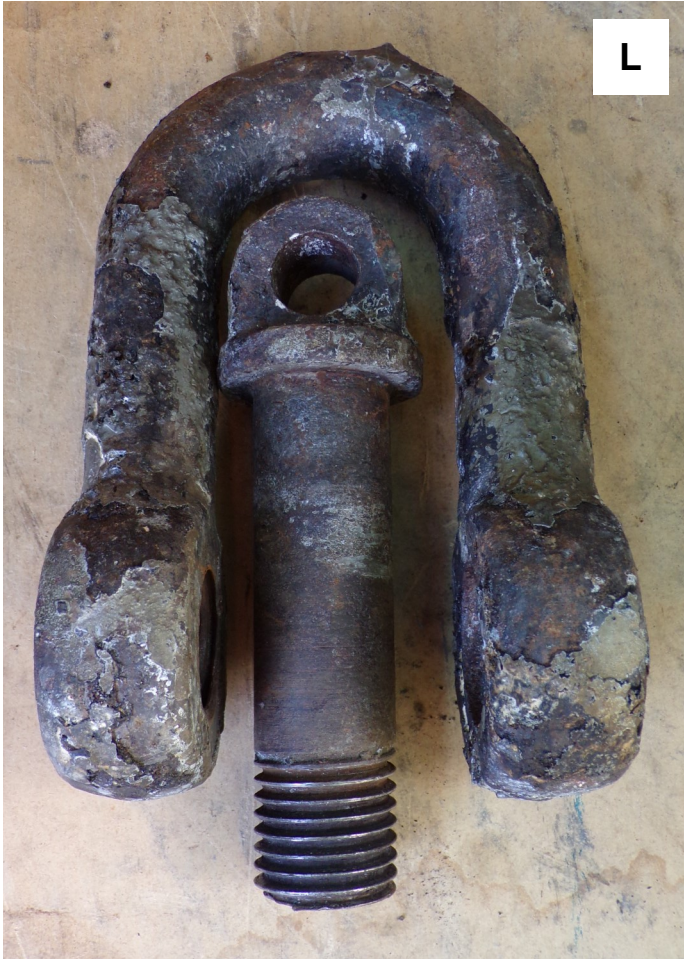
The condition of these is shown in Photographs (K) and (L) and one of the new connections in Photograph (M).

At the same time as replacing the Ground Anchor connections it was felt prudent to take the opportunity to replace all of the Upper Anchor Shackles.

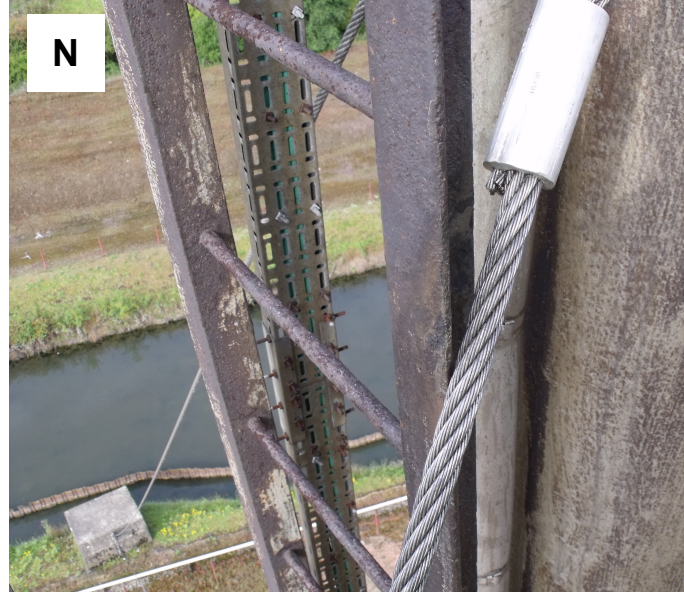
The ladder in **Photograph (N)** had always been in close proximity to the adjacent guy rope but, it had never been in actual contact.

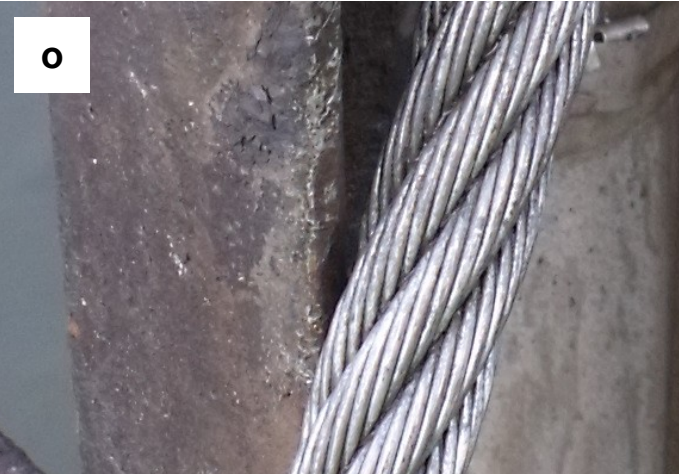
In July 2019 we observed that the ladder and guy rope were in contact and as can be seen in **Photograph (O)**, the ladder had become worn by the 'rubbing' action of the rope.

(b) The client requested that the ladder section be cut out to prevent further abrasion.

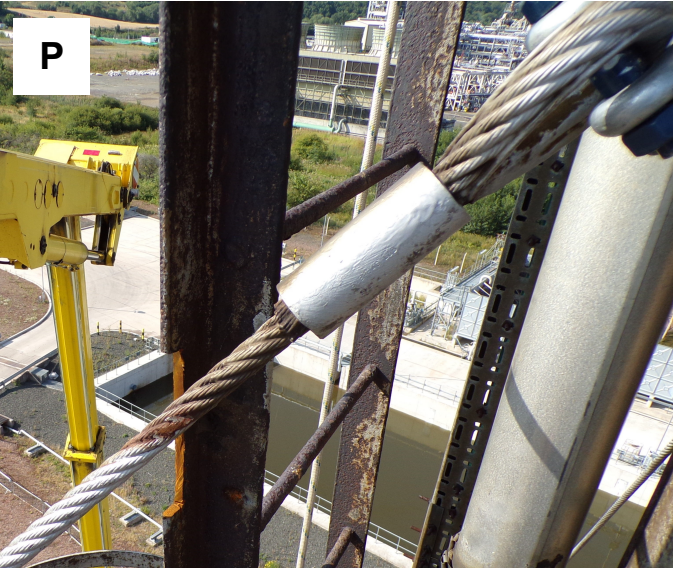
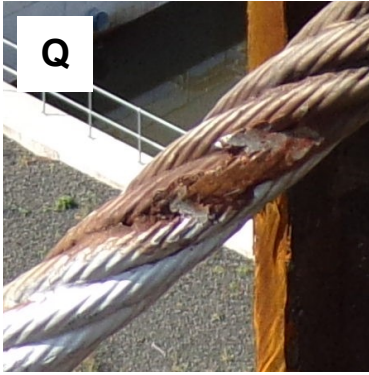
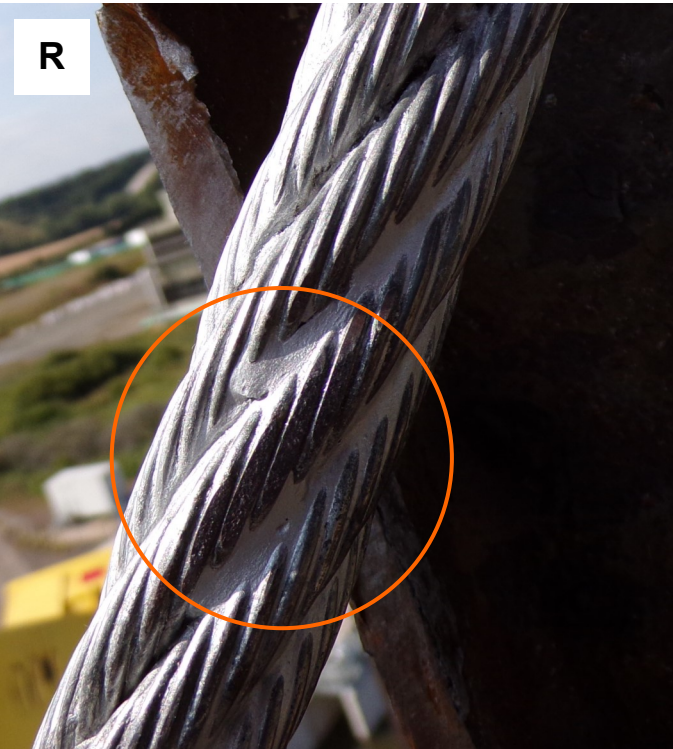
The rope itself had also become worn, **Photographs (P, Q and R)**.

The 'rust' on the guy rope Photographs (P) & (Q) was the first sign that there was contact. After the rope was cleaned Photograph (R), the extent of the abrasion became very clear.

Whilst the degree of abrasion here is not sufficient to warrant changing the rope, it is significant and, if gone undetected, would have continued to the point at which, an unplanned shut-down would have been needed to change the rope.

Notes: (a) The rope was rotated to expose the worn section.
