#### INSTALLATION & ALIGNMENT OF WIRE ROPE GRIPS (DIN GRIPS)

#### UPPER ANCHORAGES:

#### UNUSUAL MECHANICAL DAMAGE

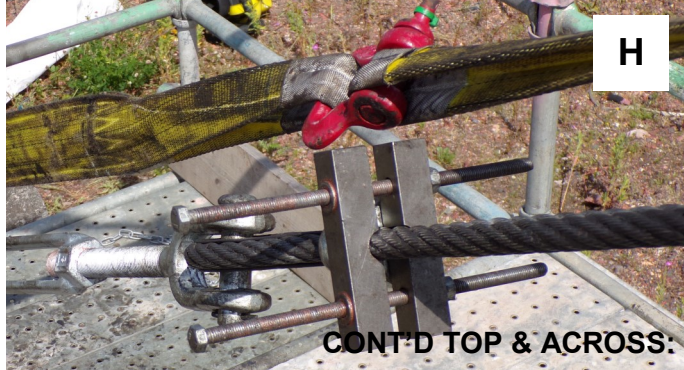
Before the grips can be fitted it is necessary to close the 'live' and 'dead' or tail part of the wire rope around the thimble; in this case the thimble is on the end of a rigging screw.

This is most readily done using a 'two bolt' rope clamp which has very long fastening bolts.

The clamp can be fitted, without too much manual effort being required to bring together the two parts of the rope, and hold them whilst the clamp is secured.

The clamp allows the rope to be tightened around the thimble and the first wire rope grip fitted close to the neck of the thimble.

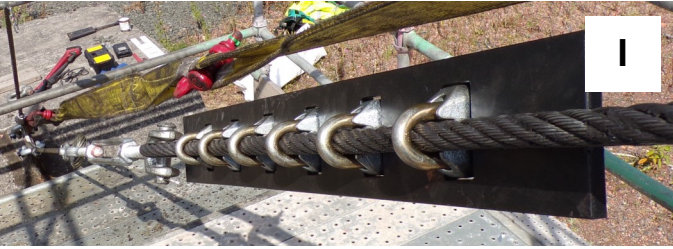
The required number of wire rope grips can now be fitted to the rope using a Ropetech 'Alignment Board'.

The board is forked at one end so that it aligns with the thimble and it has the required number of slots, correctly spaced for the particular rope diameter and which also match the dimensions of the wire rope grips.

Photograph (I) shows the 'U' part of the grips neatly aligned and correctly spaced on the 'live' part of the rope and Photograph (J) the alignment of the 'bridge' parts.

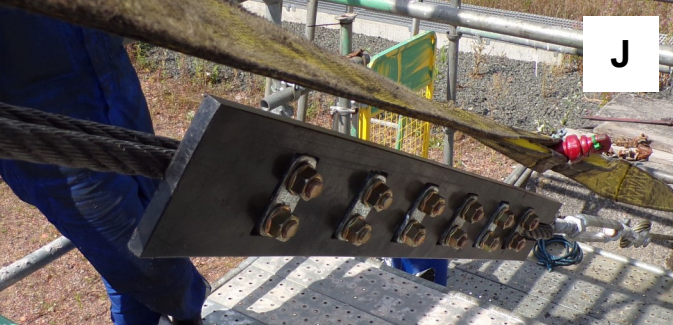
Once the grips are correctly tightened the Alignment Board can be removed.
