LOCK GATES — WIRE ROPE OPERATING SYSTEM — SURVEY, INSPECTION & REFURBISHMENT

spect the wire rope hoist systems which operate a series of three locks gates.

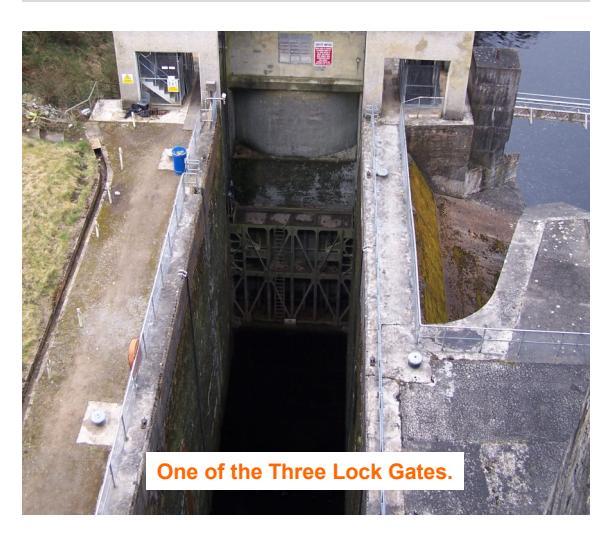
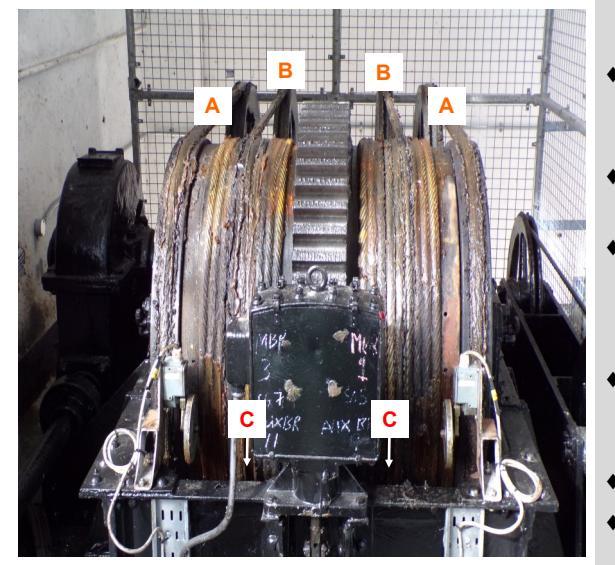
Hoist mechanism on one side of the lock. Main Balance Ropes (A) Aux. Balance Ropes (B) Sluice Gate Ropes (C)

Not only was almost everything affected by The system is complicated in that each gate a significant level of corrosion, including the rope tensioning systems (D), which were seized; but, most serious of all, was the situation at the neck of the wire rope terminating sockets (E).

> In a significant number of cases either the method of terminating the ropes had been totally incorrect or the ropes had pulled through the socket filler material; as evidenced by the parallel wires at the socket neck.

> It was determined that all of the wire ropes should be replaced, and in addition, the rope tensioning system was to be redesigned.

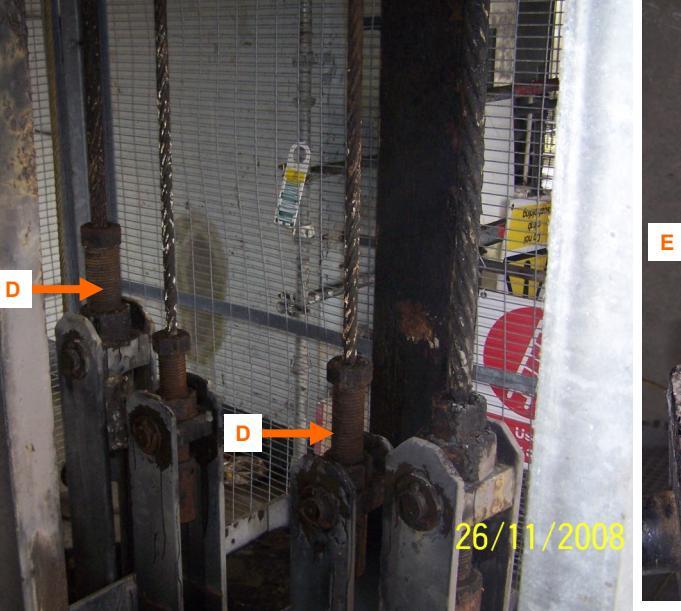
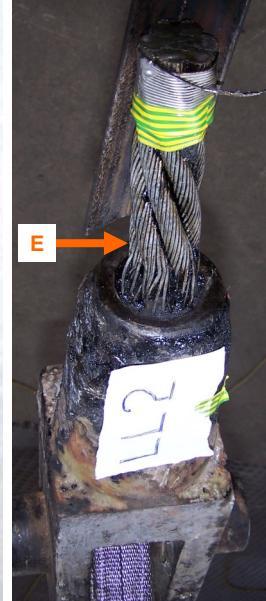
D: The ropes passed through the original tensioners hence it was not possible to see the situation at the socket neck, until the ropes were de-tensioned; which was not a simple task. It was also the case that this section of rope could not be protected from corrosion attack.

- Draw up the specifications for the new ٠ wire ropes; 4 diameters, various lengths; 24 ropes in total.
 - Obtain costs & delivery time from a number of possible wire rope suppliers.
 - Organise a new design for the terminating sockets and associated tensioners. (F) & (G) are the new design.
 - Obtain costs and delivery time from the manufacturer.
 - Organise Proof Loading & Destruction Testing of the new socket design when fitted to a sample of each of the wire ropes to be installed.
 - Because the rope lengths had to be measured on site, we cut and terminated the ropes on site.
 - Supervise the rope installation works.
 - Testing and commissioning after the ropes and associated fittings were installed.
 - Provide continuing condition assessment & supervision of necessary maintenance to date.

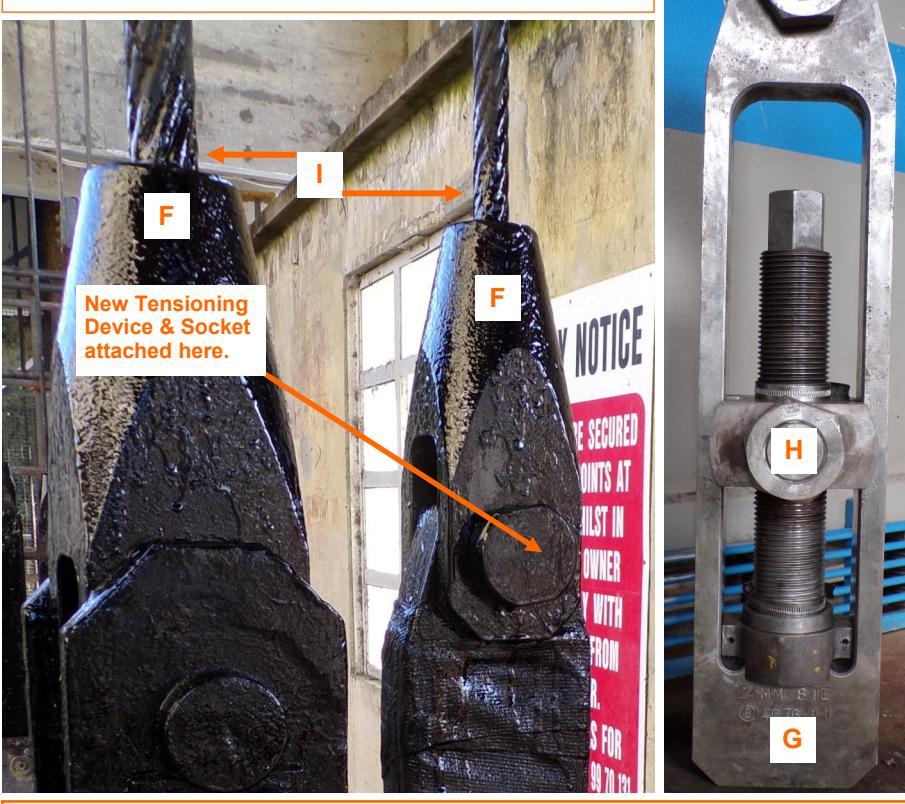
The gates are suspended from (H) meaning that the 'tensioning screws' are accessible and can be protected. The socket neck is also always visible (I).
